Large Diameter Sliplining & Large Diameter CIPP work together to rehabilitate aging interceptor sewers in Albuquerque, NM

Michael Rocco, *Trenchless Manager AUI Inc.*

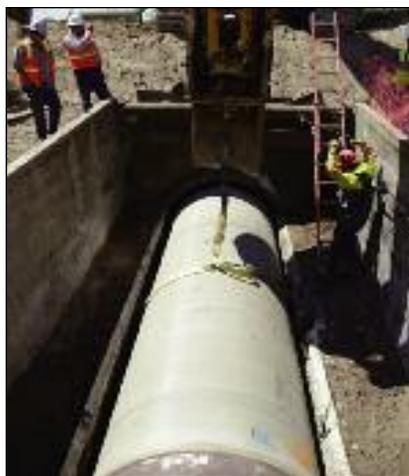
Figure 1 - 66" CCFRPM Hobas slipped into existing old 78" RCP

The biggest interceptor that was sliplined was the 78" RCP which was sliplined with 66" Hobas pipe (fig. 1). The total footage of 78" RCP that was rehabilitated was 5,234 lf. One of the most difficult jobs in this slipline process was to clean and remove all the silt from inside of the old 78" RCP. AUI subcontracted the cleaning operation to Southwest Sewer Inc. Southwest Sewer removed and hauled to the sewer plant over 1,000 tons of debris that has been laying in the old 78" sewer line. All of the slipline work was done under live conditions without the need for by-pass pumping.

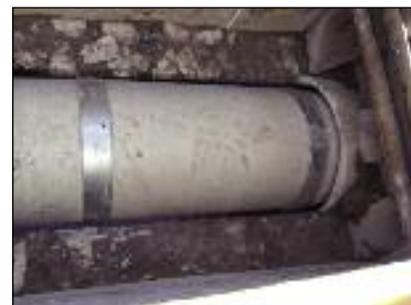
Figure 2 - CCFRPM Hobas Pipe with TeeKay Couplings at Insertion Pit

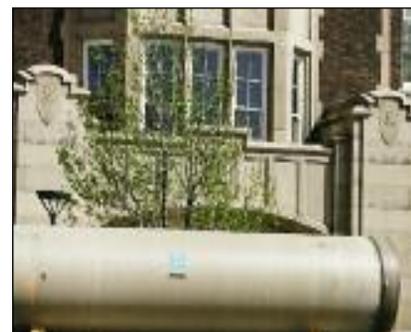
Figure 3 - 44" Hobas CCFRPM at job-site to be slipped into existing 48" RCP

The 48" sewer interceptor was sliplined with 42" Hobas pipe (fig 3). The total footage of 48" RCP

that was rehabilitated was 2,209 lf. This section of interceptor was originally installed in 1966 and the pre CCTV inspection revealed extreme exposed aggregate with hanging gaskets.

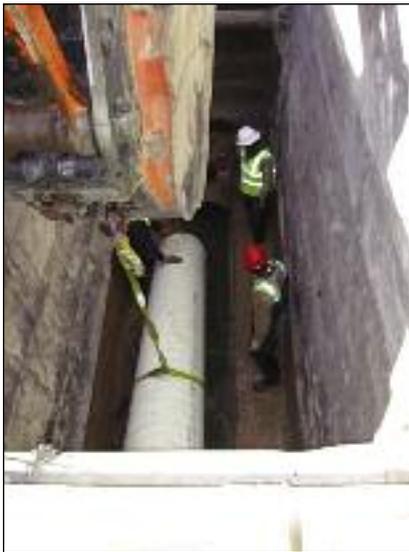
Figure 4 - 24" Vylon Pipe slipped into existing 27" RCP

Lastly, the 27" RCP was sliplined with 24" Vylon pipe (fig. 4). The total footage of 27" RCP that was rehabilitated was 3,940 lf. The sections of 24" RCP were also severely deteriorated with the crown of pipe totally gone and soil was exposed. Pre CCTV inspection revealed a total of three active sewer services which were reconnected at depths of up to 18 feet.

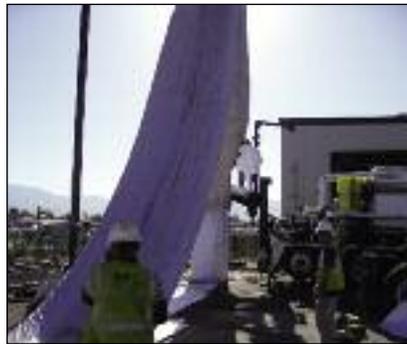
Figure 5 - 48" CIPP installed into existing 48" RCP

The total 48" RCP that was Cured In Place was 3,772 lf (fig. 5). The sewer line was by-passed with 100% back up pumps in order to allow the CIPP process to proceed. Over 5,300 lf of 18" HDPE was used as the discharge line to support the by-passing of the sewer line. The 48" sewer line snaked through backyards of residents and business. One man-hole was located in a homeowner's property.
